NORTH FREMANTLE RAILWAY BRIDGE COLLAPSE 1926

An accident waiting to happen?

Heather Campbell

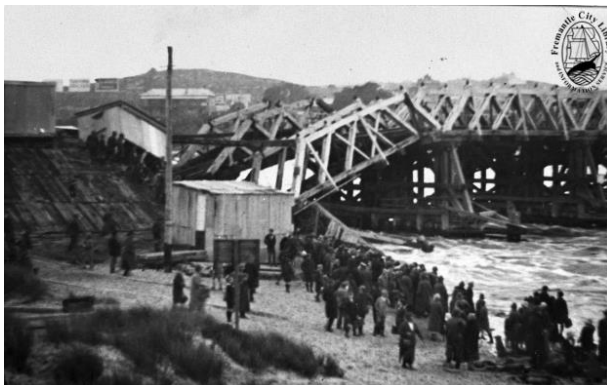
The collapsed Railway Bridge, 22 July 1926,
(Fremantle City Library Reference 3375)

... Heralded by the rumble of loose sand and rocks falling into swirling water and the creaking and groaning of strained timbers, a considerable portion of the northern end of the railway bridge which spans the Swan River at Fremantle collapsed yesterday afternoon and was washed at a tremendous speed down the harbour and into the ocean by the flood waters of the river. That the disaster occurred without loss of life can be regarded as miraculous for, a few short minutes before the general collapse of the bridge took place a passenger train from Fremantle, bearing a human freight which included several children thundered over the weakened structure. After the train had passed, the condition of the abutments of the bridge was noticed and the alarm raised. Instantly railway officials at North Fremantle and Fremantle acted and all traffic between North Fremantle and the central station was suspended. This was done only just in time for a train from Perth was stopped as it entered the North Fremantle station a few minutes after the disruption of the bridge had commenced and a goods train out of Fremantle was signalled to stop at the junction leading on to the bridge on the south side. ... That the occurrence would prove a severe blow to the Port was generally recognised. It would mean, it was stated, that the southern side of the harbour was practically isolated as far as cargoes coming from Perth were concerned ... Although, yesterday, no announcement was made, it would appear that the majority of the vessels using the harbour in the near future will be berthed at the North Fremantle quay, the railway facilities of which have not been affected by the breakage of the bridge...

The first sign that anything untoward was happening was a crack which appeared in the embankment. When this was noticed the damage had been done, for, as each wave lapped the stones the embankment was weakened more. Within a few minutes the bridge was damaged to such an extent that repair appeared impossible. A heavy mass of masonry gave way, and taking with it protecting timber, crashed into the water and was closely followed by beams from the bridge, which were left without support at one end. Through the gap thus created the torrent raged and it was only a matter of time before a gap of nearly 100ft. yawned between the bank and shattered end of the bridge. Throughout the afternoon pieces of timber cracked and fell, and in falling, weakened other timbers, which, in turn soon became the playthings of the river. Not only were the timbers of the bridge continually falling but the embankment, too, was eaten away. ...

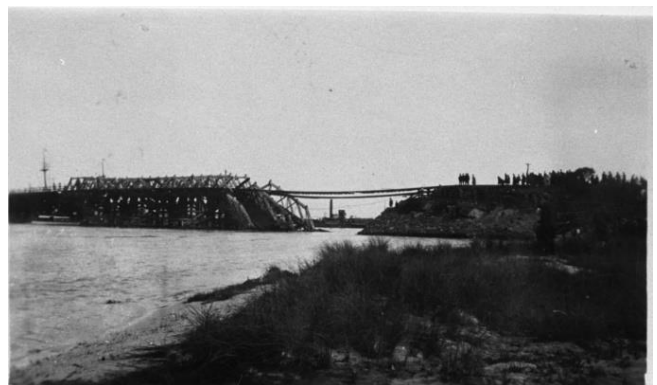
The collapse of Fremantle Railway Bridge, 1926
(Fremantle City Library Reference 3631)

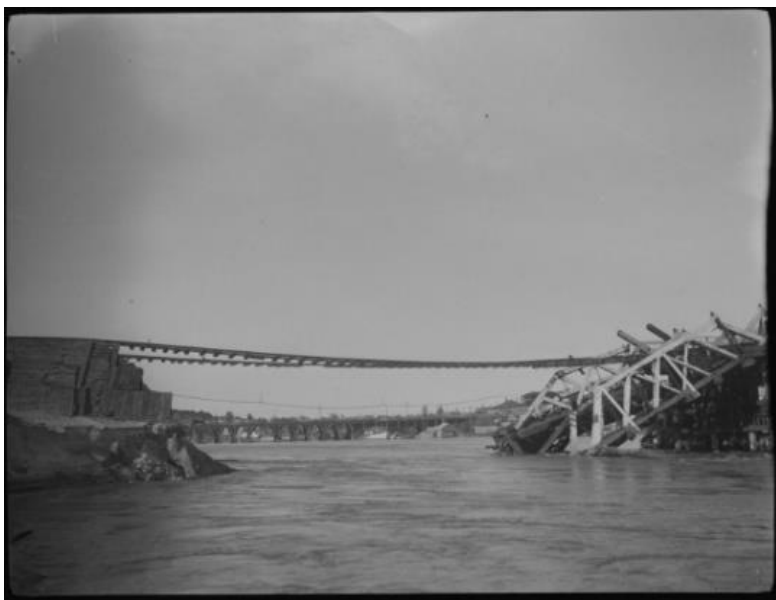
Fremantle Railway Bridge, collapsed
22 July 1926
(SLWA 217691PD)

the northern abutment on the previous day. At the time he did not regard the matter as serious, but when he inspected the spot again early yesterday afternoon he was perturbed to find that the crack had opened slightly. Whilst he was inspecting the fissure the 1.12 p.m. train passed over the bridge, and a few moments later he was horrified to see the gap open to a width of five or six inches. Conscious of the exceptional pressure of flood waters that were swirling against the embankment and the bridge supports, he realised that it would be only a matter of minutes before the aperture would be considerably widened, and a large portion of the abutment swept away. Instantly he clambered up the railway embankment and conveyed his startling tidings to a party of fitters who were working on the permanent way. Ganger Hogan, who was in charge of the party, acted without loss of time. He instructed a flagman to carry the news to the officials at the Fremantle station, and then set off to warn the stationmaster at North Fremantle. Prompt as was the action of Henderson, Hogan, and the workmen, their warning was not given a moment too soon. A goods train had actually left the Fremantle yards, and was approaching the bridge when a flagman arrived with the tidings that held it up and saved it from almost certain disaster. At North Fremantle the 1.5 [sic] p.m. passenger train from Perth arrived about 15 to 20 minutes after the alarm had been given...¹⁶

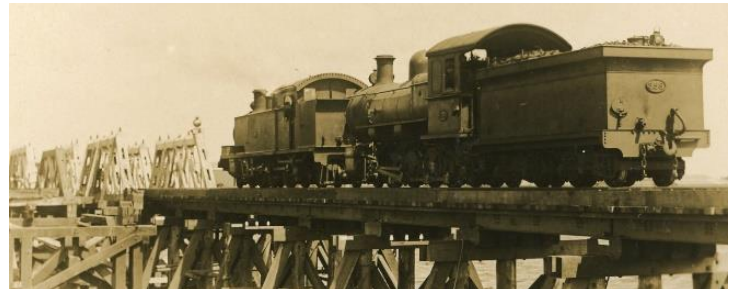
'Light and heavy engines combined'
From *Sunday Times* 24 Oct 1926 p. 13

By mid-October repair work was completed after several months of disruption to rail traffic¹⁸ and loss of trade for Fremantle businesses'¹⁹. Tests made 'with light and heavy engines combined' were 'quite satisfactory' and 'direct railway traffic from Perth and Fremantle' was re-established.'²⁰
